CURRENT TRANSFORMER DOBLE TESTING TRIPPING UPSTRING BREAKER

Hugo Simard, Rio Tinto
Long Pong, Doble Engineering

ABSTRACT

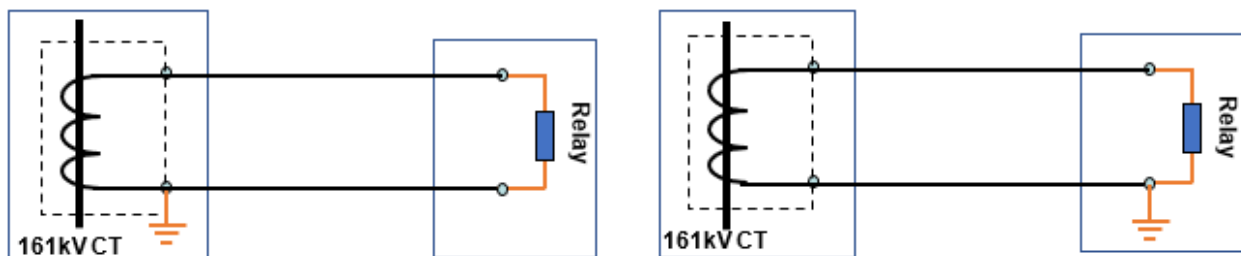
Secondary Grounding Methods for Testing CT Primary Insulation
Figure 1

There are two philosophies to ground the CT secondary circuit in Rio Tinto's installations. In the new design, the secondary windings are grounded according to the IEEE C57.13.3-2014 standard [3], i.e. the ground is in the relay panel located in the control room in Figure 1b and therefore the ground could distance from the CT several hundred feet. In the old design, the CT secondary windings had been grounded in the junction box of the CTs located in the substation and connected to the station ground, shown in Figure 1a according to the old IEEE C57.13.3-1983.

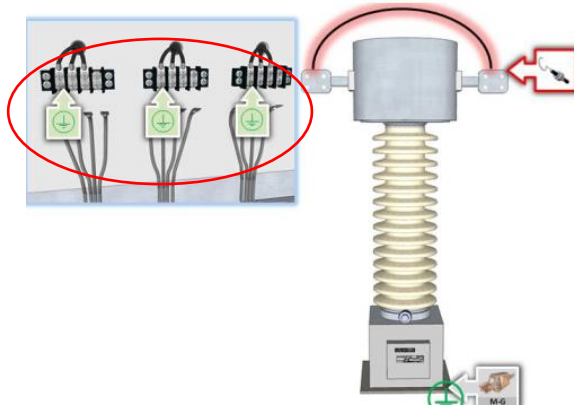
**Test Setup Recommended by Doble
Figure 2**

- Isolate the CT primary terminals and shorted (H1/H2).
- Isolate the CT secondary terminals shown in the red circle of Figure 2.
- Grounding secondary terminal on each secondary winding (Ex.: X1, Y1, Z1), may be short-circuited too, but this is not necessary.
- Set up and perform the insulation test on HV primary.

Note: This requires re-connection and functional verification after testing - disadvantage of this method

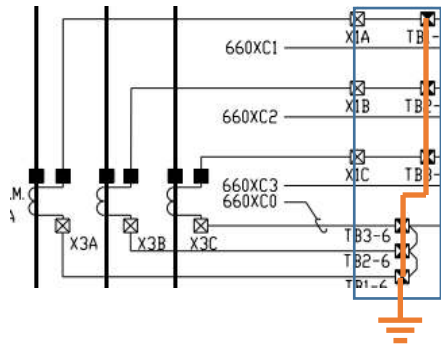
**Circuit Diagram of Collective practice
Figure 2**

For more than 20 years, the insulation tests have been performed by installing a short circuit on all secondary terminals and then connecting them to earth in the three-pole cabinet of all 3 current transformers in the substation (Figures 3 and 4). No verification of an existing ground in the secondary circuits is done. This method is described in detail as an in-house procedure [2] when servicing a current transformer. In the past, no events or disturbances have been observed and no incorrect insulation measurements were obtained using this procedure.

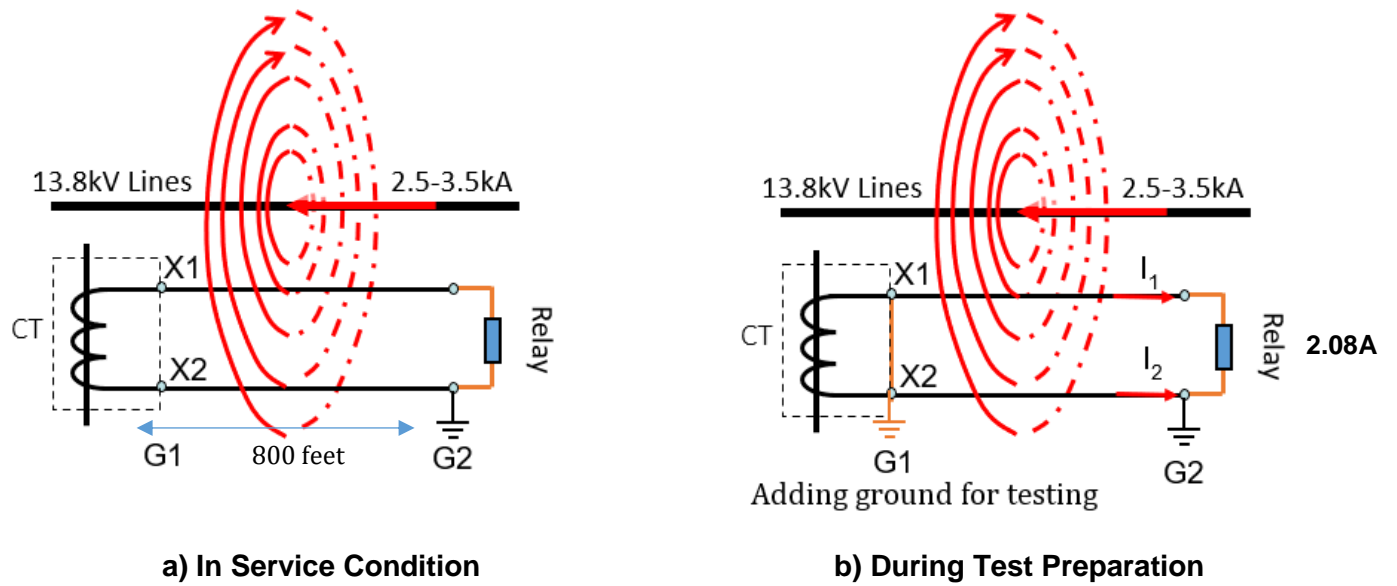
**Circuit Diagram of CT and Adjacent Line
Figure 4**

The electrical substation is approximately 800 feet from the protective relays located in the control room and has two power lines sandwiching the CT secondary circuits. The first power line is rated 13.8kV carrying the load currents between 2500-3500A (Figure 6a) and the second line is rated 161kV carrying about 100A (Figure 6b). The distance between the power lines and CT secondary circuit is about 40 feet and the power lines are in parallel for 800 to 1000 feet. In service condition, this installation has one ground on the CT secondary circuits located in the control room as shown in the terminal G2 (Figure 5a) and no ground at the current transformer side.

During test preparation, shorting and grounding jumpers were installed on the CT secondary terminal G1 located in the CT cabinet at the CT side. The additional ground formed two loops between the two grounds G1 and G2, (Figure 5b), then coupled with the magnetic field coming from the adjacent power lines carrying high load currents. This resulted in two current circulations I_1 and I_2 ; the current I_1 went through the protective relay before reaching G2 causing the electrical protection system to operate and ultimately trip the 161kV circuit breaker. Based on historical relay data, 2.08 amps circulated in the relay (see Appendix). Several customers were affected by this inadvertent outage.

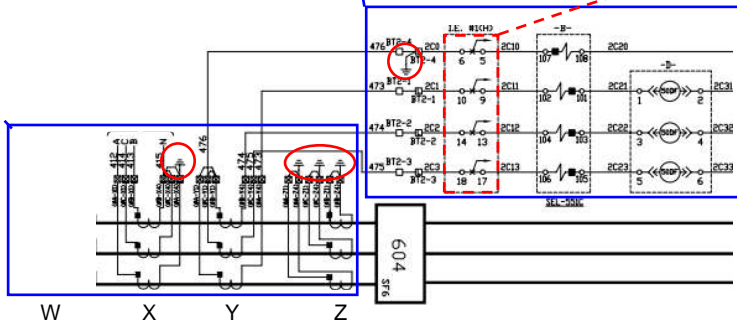
d) Circuit diagram of CTs and protection system

We analyzed the typical electrical circuit of a current transformer and how the Flexitest switch is connected to identify that the ground of secondary circuits W, X and Z were connected in the three-pole junction box at the CT side in substation (Figure 7a) and the other circuit Y was grounded in the protection cabinet in the control room (Figure 7b).

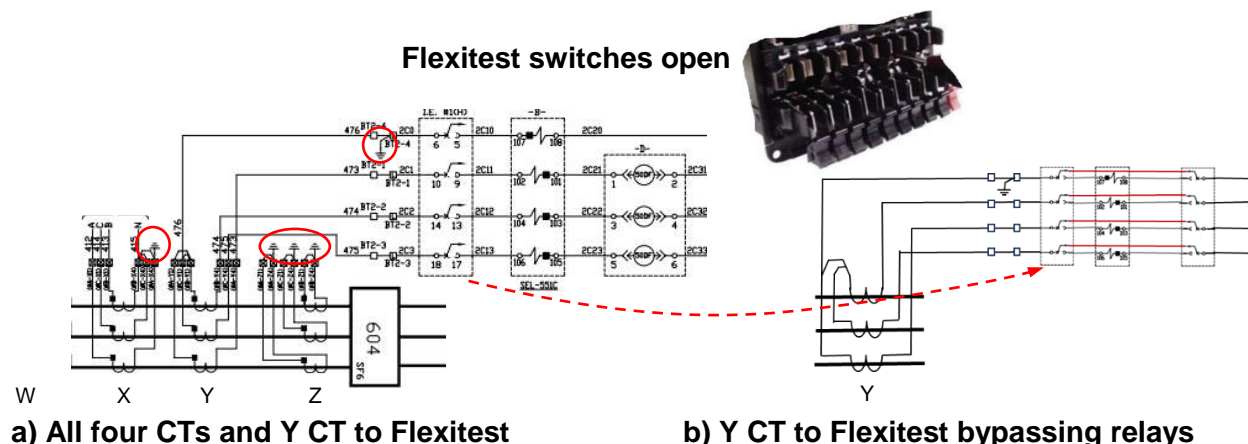
**In-testing CT Condition of Protection System Components
Figure 8**

The operating principle of Flexitest switches is to provide a safe and reliable means for in-service testing of relays. Therefore, in the open position, they completely isolate the relays from the CTs to prevent a current circulation from any sources, and at the same time they short the CT secondary terminals and preserve the grounds on CT secondary circuits as shown in Figure 8.

For the next step, we decided to perform the insulation test on the CT HV primary winding without disconnecting the burden circuit from the CT secondary while simultaneously using the Flexitest switches to isolate the burdens (relays) as shown in Figure 8. This was to check for any impact on the test results. The final step was to make sure that the testers didn't forget to close the Flexitest switches before returning the CTs to service. For this, we added control steps in the safety procedure while making and releasing the securing safety zone. We then repeated all the standard insulation tests on CTs using this test setup. All insulation test results (%PF and capacitance) were acceptable and consistently comparable to the previous method tests, as shown in Table 1.

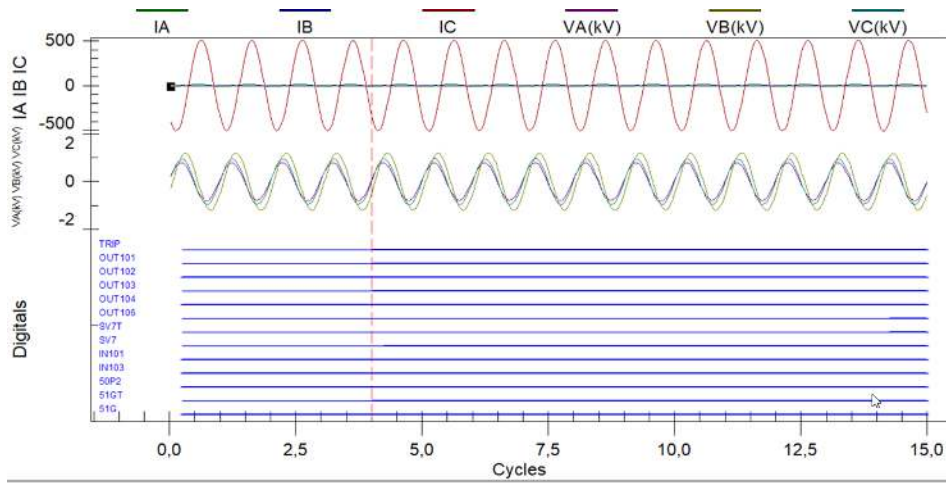
351 (50S) Relay, 500A PHC Primary Current During Event

Un courant de 500 ampères a été vu sur la phase C au primaire, ainsi on sait qu'un courant de 2,08 ampère a circulé au secondaire dans le relais 351 (TC 1200:5) Puisque le courant a persisté pendant 10 cycle suite à l'état ouvert du disjoncteur, (50S) Le relais 351 a alors déclenché la sortie 106 qui fais déclencher la protection différentielle de la barre C. (87D)

En appliquant court-circuit au ground sur la phase C, les électrotechniciens ont créé un différence de potentiel entre le ground de la BJ tripolaire et le ground de la salle de commande. **Ainsi, une tension de quelques volt entre la BJ tripolaire et la salle de commande aurait pu engendré un courant d'environ 2 A puisque l'impédance de la boucle est faible.**
